COMBINED FIRE AND HEALTH & SAFETY RISK ASSESSMENT.

Address of premises:	1-34 The Maltings Vale View Royal Wooten Bassett SN4 7EZ
Responsible Person:	Vale View Management Company Limited
Duty Holder:	Block Management Limited
Person(s) consulted:	No occupier or other relevant person available to consult.
Assessor:	Rob Cockburn
Report validated by:	John Godfrey, GFireE.
Date of fire risk assessment:	4 th November 2025
Date of previous fire risk assessment:	September 2023
Suggested date for review:	November 2026

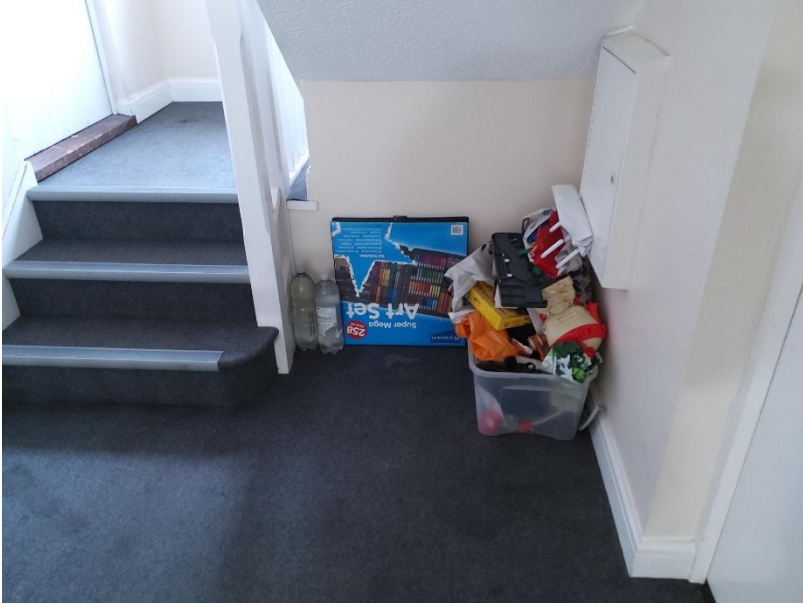
Item	Recommendation	Priority	Timescale
01	<p>Housekeeping was found to be of a poor standard at the time of this assessment within entrance 23-33 with the communal areas and escape routes congested with residents' possessions and storage. It is recommended that the client arrange for the communal areas to be cleared as a priority and all residents reminded of the importance of maintaining sterile communal areas and escape routes.</p>

Ongoing action required

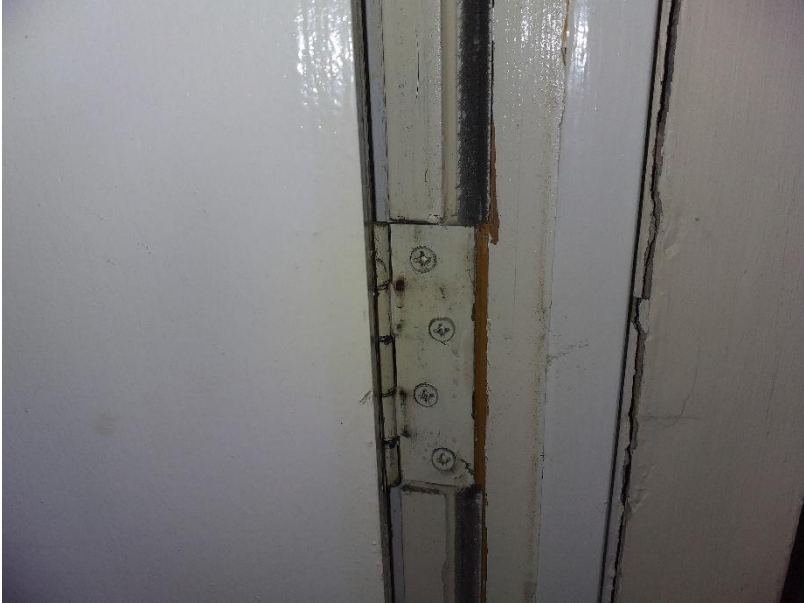
02	<p>It was noted during this fire risk assessment that the identified communal area doors had the following deficiencies:</p> <ul style="list-style-type: none"> • No fire rated hinges on all lobby doors • Server door is not a suitable fire door <p>It is essential that each door communicating with the means of escape is a suitable fire door, providing a minimum of thirty minutes fire resistance, hung on three grade 13 hinges, combine cold smoke and intumescent seal, “Fire Door Keep Locked” or “Fire Door Keep Shut” signage where appropriate along with having a functioning self-closing device fitted that positively closes the door flush to the frame if a lobby door. It is recommended therefore that the RP instruct a suitably qualified and competent contractor to conduct a fire door inspection to all communal area doors providing advice on suitability. Any shortcomings identified by this inspection should be addressed as a priority by upgrading or replacing the door. Flat entrance doors, communal area doors, the seals and the self-closing devices should then be subjected to an annual inspection and maintenance schedule.</p>

2	B	<p>Ongoing action required</p> <p>Contractor to action as appropriate</p> <p>Inspection carried out in accordance with current legislation.</p>

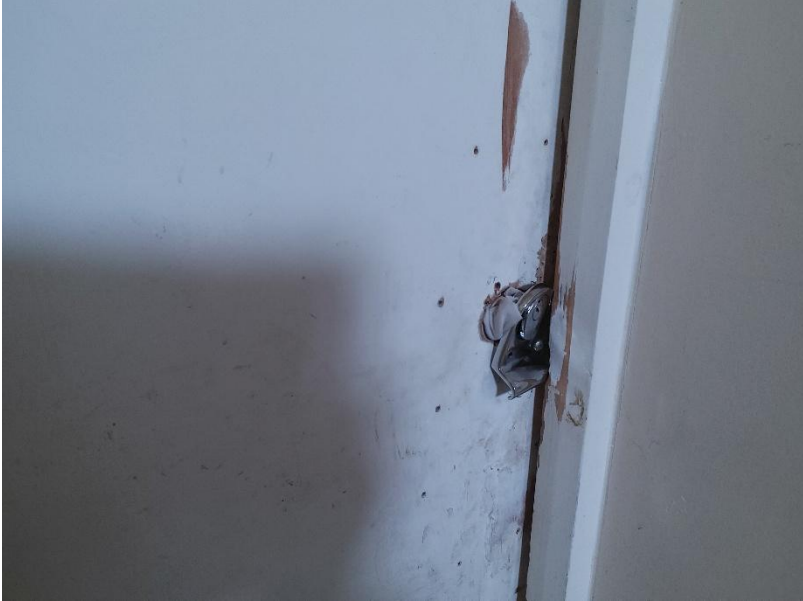
03	<p>As per section 33.2 of Fire Safety in Purpose-Built Block of Flats a type 1 fire risk assessment requires us to conduct a fire door survey on a sample of flat front doors. Doors to Flats 18 and 19 were surveyed during this sample in which the following deficiencies were found:</p> <ul style="list-style-type: none"> • No fire rated hinges • Flat 18 has a breach in the door • No smoke seals • Flat 19 does not fully self-close <p>It is essential that each flat entrance door is a suitable fire door, providing a minimum of thirty minutes fire resistance, hung on three grade 13 hinges and having a functioning self-closing device fitted that positively closes the door on the latch, together with smoke and intumescent seals. It is recommended therefore that the RP instruct a suitably qualified and competent contractor to conduct a fire door inspection to all flat entrance doors providing advice on suitability.</p>	1	B	<p>Ongoing action required</p> <p>Inspection carried out in accordance with current legislation</p>

<p>Any shortcomings identified by this inspection should be addressed as a priority by upgrading or replacing the door. Flat entrance doors, communal area doors, the seals and the self-closing devices should then be subjected to an annual inspection and maintenance schedule.</p>

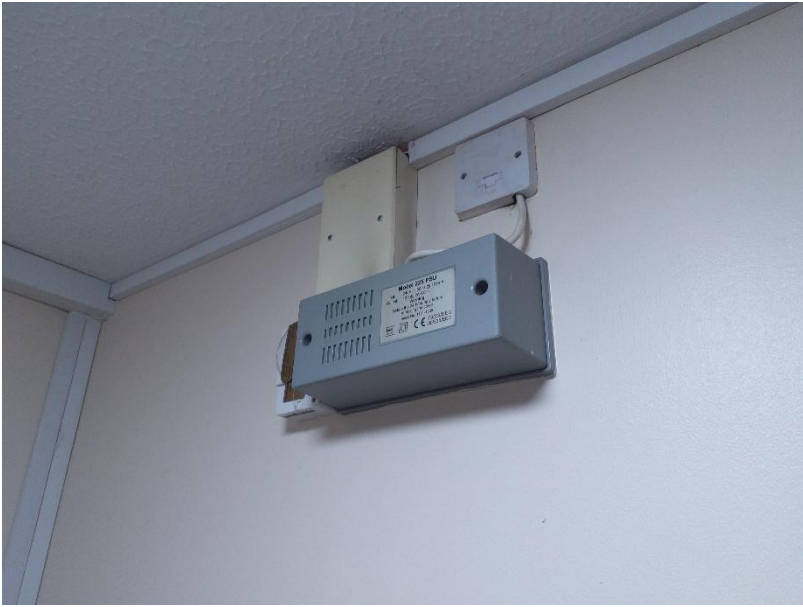
<p>04</p>	<p>It was noted during this fire risk assessment that the fixed electrical installation within entrance 1-5 is exposed to the means of escape which could allow smoke and fire to spread into the means of escape. It is therefore recommended that the RP instructs a suitably qualified and competent contractor to either encase the fixed electrical installation in metal or a material capable of providing a minimum of 30 minutes fire resistance.</p>

<p>2</p>	<p>B</p> <p style="text-align: right;">Action required</p> <p>Contractor to provide advice and action accordingly</p>

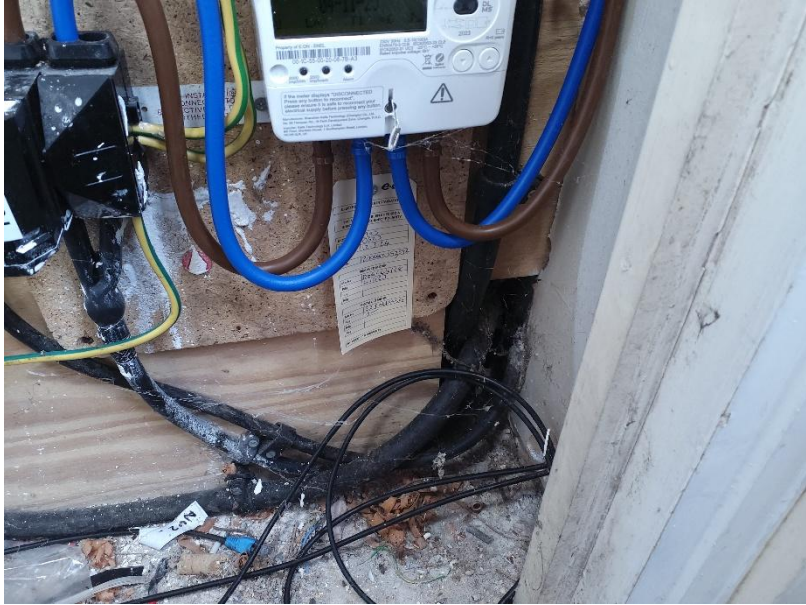
<p>05</p>	<p>It was noted during this fire risk assessment that there were breaches in the compartmentation in the following areas:</p> <ul style="list-style-type: none">• Breach in the electrical intake cupboard in entrance 18-21 <p>It is therefore recommended that the RP instructs a suitably qualified and competent contractor to repair the breaches with a suitable compound capable of providing a minimum of 30 minutes fire resistance in order to minimise the likelihood of fire spread and to protect the means of escape as per Section 17 “Compartmentation” in Fire Safety in Purpose-Built Block of Flats.</p>

<p>2</p>	<p>B</p>	<p>Action required Contractor to action</p>
-----------	---	----------	----------	---

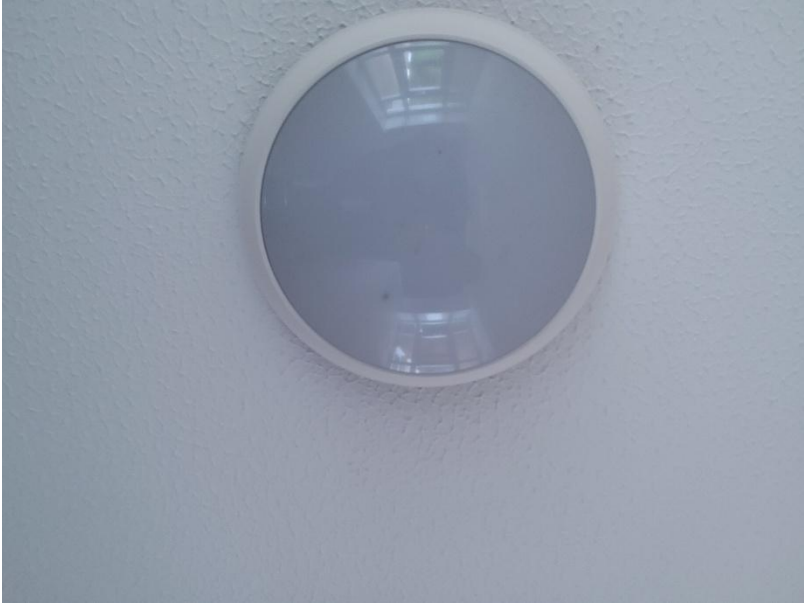
06	<p>Emergency lighting is installed within the common areas of entrance 23-33 however the emergency lighting does not appear to be charging. This could delay a safe and prompt evacuation in low ambient light conditions. It is recommended that the client consult with a competent contractor to conduct a light level assessment and emergency light fittings be repaired and/or upgraded where required to ensure adequate emergency lighting levels of all escape routes.</p>

1	B	<p>Ongoing action required</p> <p>Electrician is making repairs.</p>
07	<p>It is recommended that a suitable written record of periodic visual inspections of all access routes to the premises is implemented by the RP. This should include a record of the condition of external steps and pathways. Any defects identified should be communicated to each resident and repaired by an approved contractor as a priority.</p>	3	C	<p>Ongoing action required</p> <p>DH inspect and action as required</p>

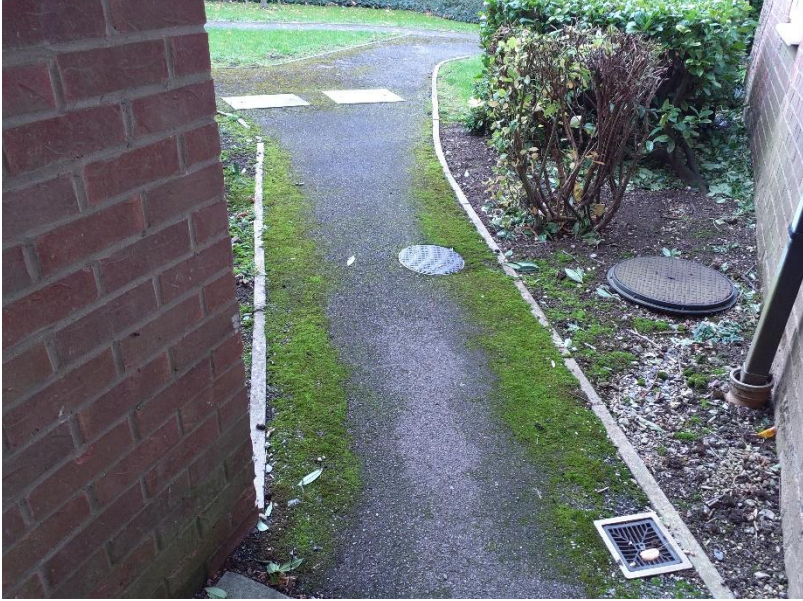
• Are there any other safety issue concerns?	NO
31.2	Comments and hazards observed:	
<p>It was noted during this assessment that there is a buildup of moss on the rear approach paths to 8-15 and 23-33. It is recommended that all moss be removed and the approach paths be monitored for moss buildup as it presents a significant slip hazard.</p>

09	It is recommended that the RP implements regular communication regarding vital safety messages, A "Resident's Handbook" (which can be published on the RP's website), general advice on domestic fire safety and preventing fires in the home, along with regular targeted campaigns of leafleting and other initiatives to promote fire safety to keep it fresh within the resident's minds.	3	C	Ongoing action required DH provide information via notice board and website
10	<p>It was noted during this assessment that there is a buildup of moss on the rear approach paths to 8-15 and 23-33. It is recommended that all moss be removed and the approach paths be monitored for moss buildup as it presents a significant slip hazard.</p>

2	B	Ongoing action required Gardening contractor has been asked to action and monitor
